MISCELLANEOUS PAPER C-77-9

**ACID ATTACK OF CONCRETE CAUSED BY
SULFUR BACTERIA ACTION, PIEDMONT AND
CLENDENING LAKES OUTLET TUNNELS
MUSKINGUM WATERSHED, OHIO**

Concrete Laboratory
U. S. Army Engineer Waterways Experiment Station
P. O. Box 631, Vicksburg, Miss. 39180

August 1977

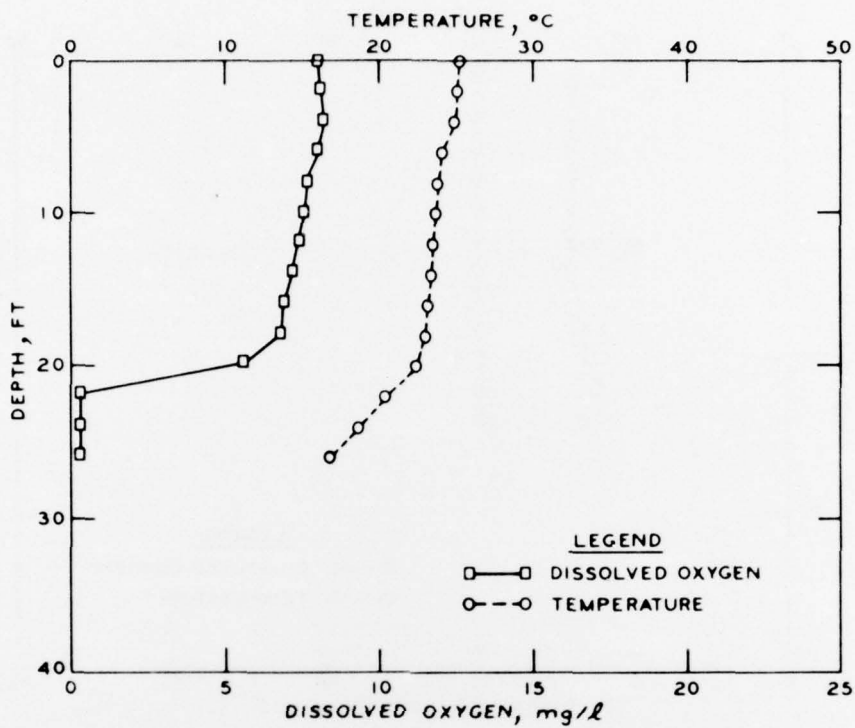
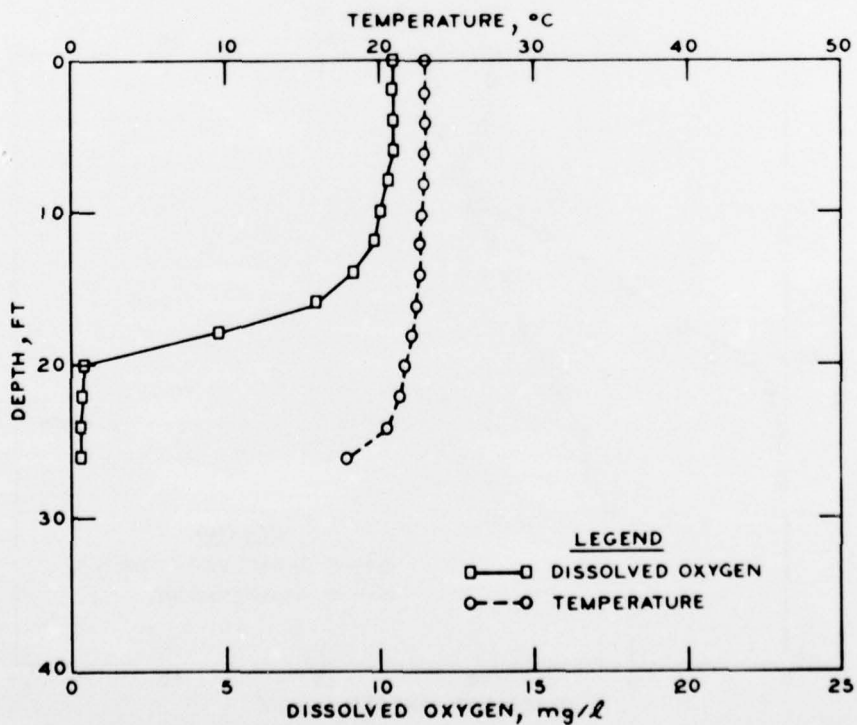
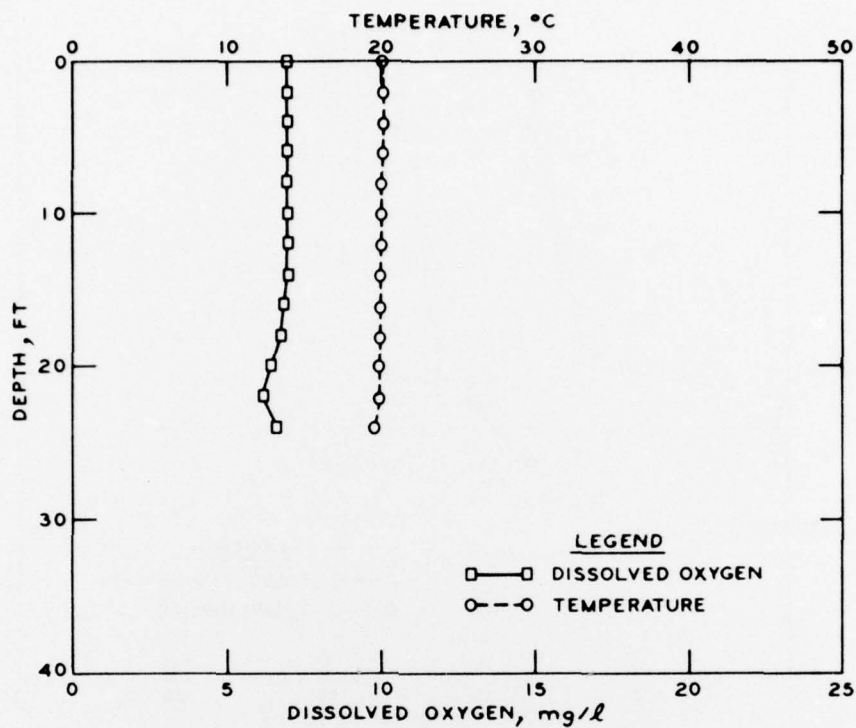
22. Tables 3 and 4 give the temperature and dissolved oxygen profiles with water depth for Piedmont and Clendening lakes, respectively. July data for 1973 through 1976 are compared to show typical conditions during the summer months at Piedmont. November 1973 and September 1976 data are given to show how conditions begin to change in the fall. Data given for Clendening Lake include days in August of 1974, 1975, and 1976, and September 1976. The July 1976 and September 1976 data, Piedmont Lake, are plotted in Figures 1 and 3, respectively. August 1976 data (no tabulation available) are plotted in Figure 2. Clendening Lake data from June, July, August, and September 1976 are plotted in Figures 4-7. These data were obtained from collection points in the deep parts of the lakes near the dams, PES20002 at Piedmont, CLB20002 at Clendening, and show that dissolved oxygen depletion occurs in the summer months at depths of 20 to 22 ft and below at Piedmont, and at depths of around 15 ft and below at Clendening Lake. Plots of data (Figures 3 and 7) collected in the early fall illustrate the return of uniform distribution of temperature and dissolved oxygen with depth due to natural cold-weather mixing action. A study of all the data furnished by Huntington District indicates that dissolved oxygen depletion begins in Piedmont Lake in early June and lasts into September, when stratification starts to break down. There were insufficient data to determine when this cycle starts at Clendening, but mixing action starts in September.

Figure 1. Piedmont Lake, 15 July 1976

Figure 2. Piedmont Lake, 19 August 1976

Figure 3. Piedmont Lake, 22 September 1976

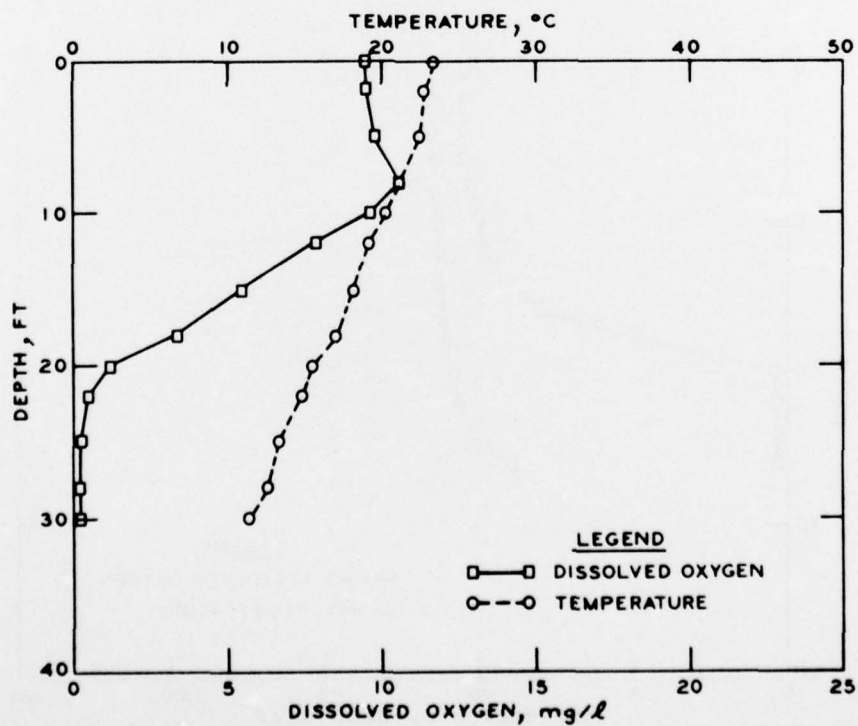
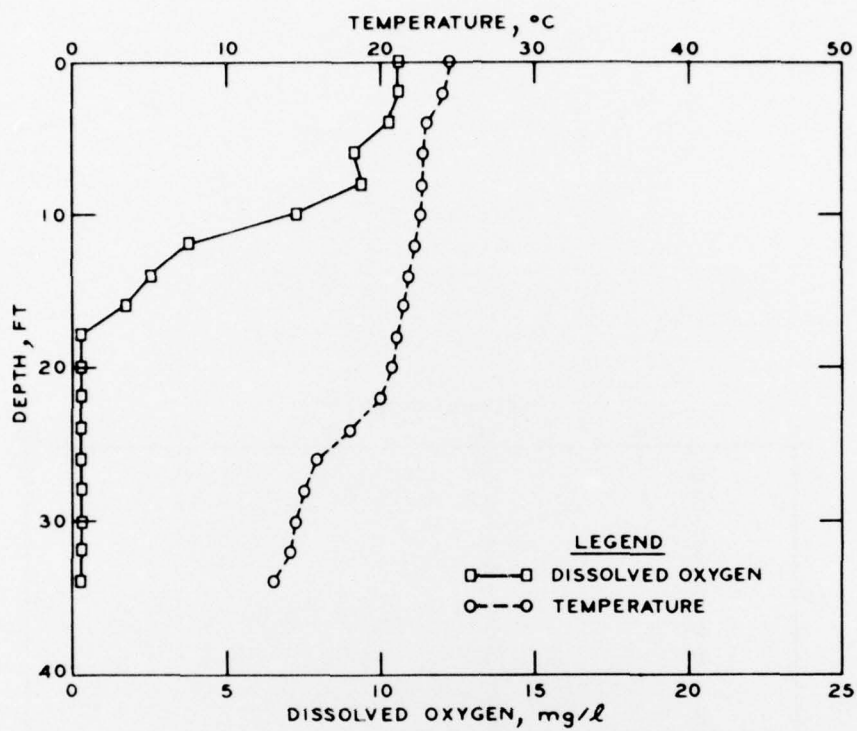
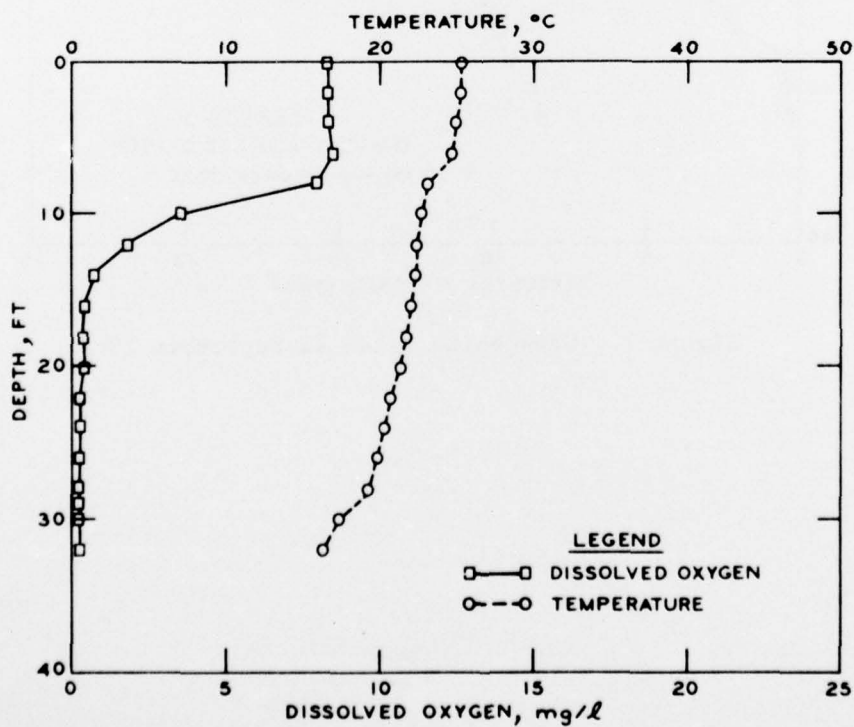
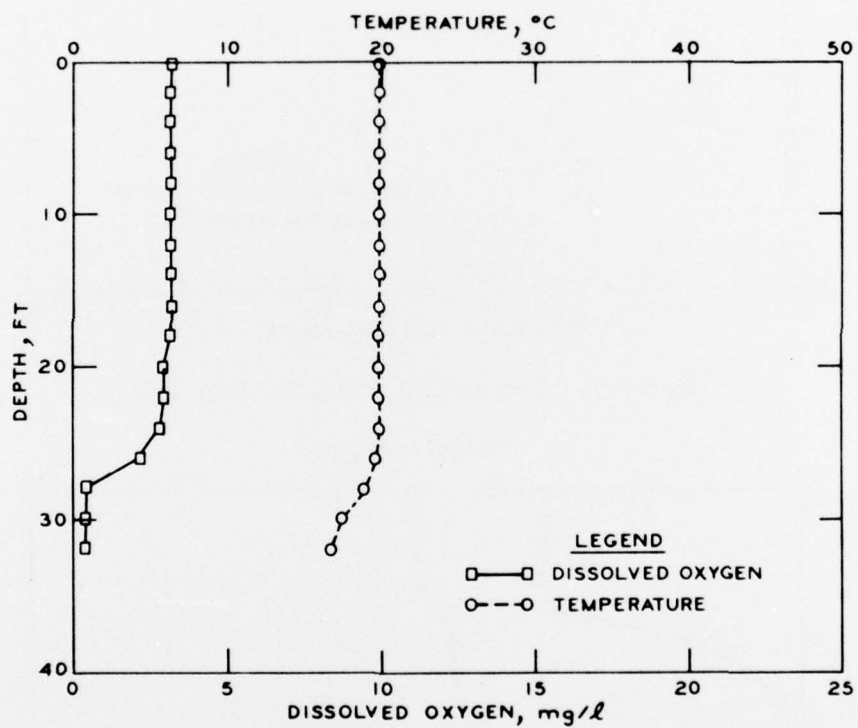
Figure 4. Clendening Lake, 9 June 1976

Figure 5. Clendening Lake, 14 July 1976

Figure 6. Clendening Lake, 18 August 1976

Figure 7. Clendening Lake, 22 September 1976

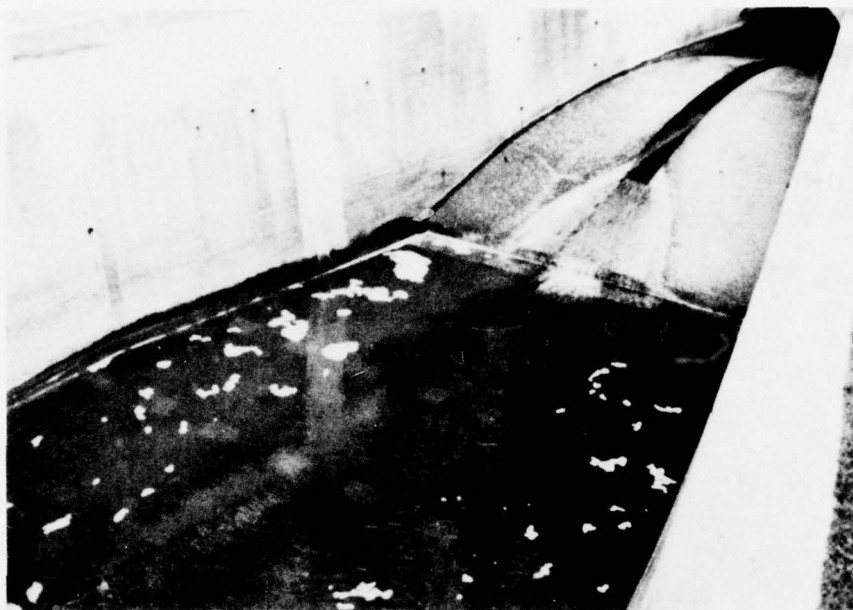
11. The water in the stilling basins and in the streams at both projects was of a pale blue color with a white foam floating on it (Photographs 3 and 4). The lines of normal flow were clearly discernible by the water marks on the sides of the tunnels. About one-third of the way into the tunnels the deterioration became evident above the normal flow lines (Photograph 5). In the vicinity of the gate-transition areas the deterioration was more pronounced (Photograph 6). The conditions inside the tunnels were very similar to those described by Parker⁶ when relating to acid attack in concrete sewers.

Photograph 3. Clendening Lake, view showing rising
invert with slot

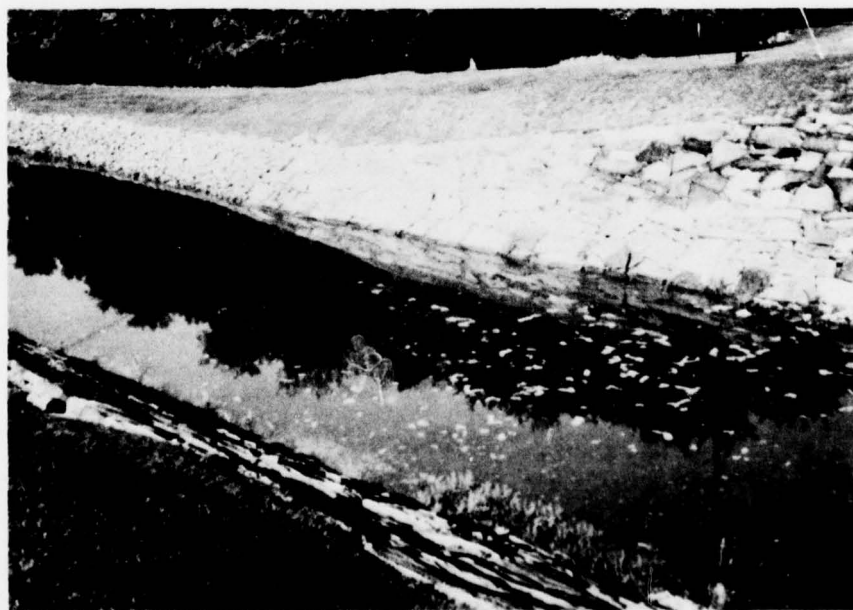
Photograph 4. Clendening Lake, view downstream of
stilling basin

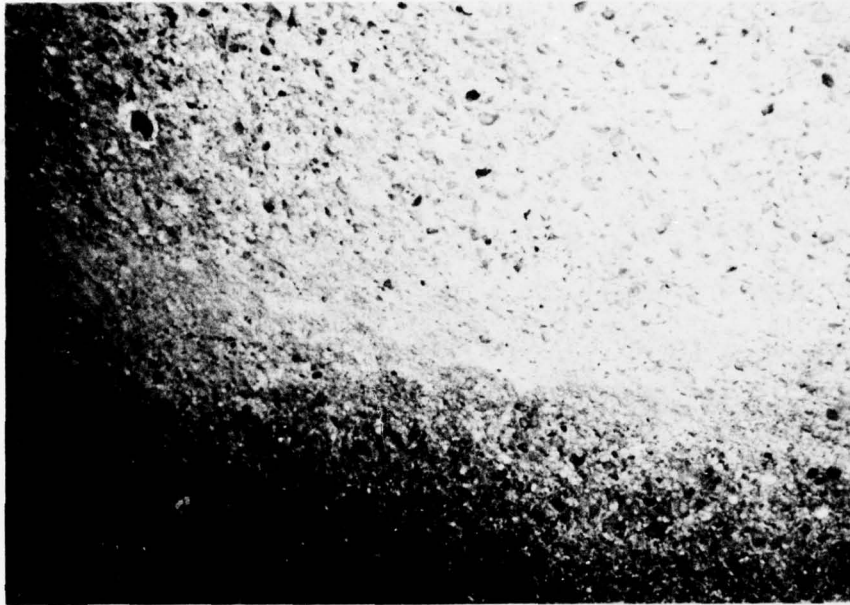
32. After an evaluation of the summation of test results and other accumulated data and information pertaining to this investigation, it is concluded that the deterioration of the concrete in the outlet tunnels of Piedmont and Clendening Lakes is most likely due to acid attack and is the final stage of a corrosive process caused by sulfur bacteria action. The process starts with the production, by bacteria, of hydrogen sulfide from the sulfate-rich water in the lake, and by organic decomposition in the sediment. The hydrogen sulfide passes through the siphons and gates and is released into the atmosphere in the gate-transition area due to the turbulence of the water. The hydrogen sulfide collects in the crown of the tunnel in concentrated amounts for some distance down the tunnel, is oxidized into sulfuric acid by concretivorus bacteria, and the constituents of the cement paste are decomposed by the acid. Physical mechanisms such as freezing and thawing and hydraulic washing probably aid the corrosive process.

Photograph 5. Clendening Lake, deterioration
above normal flow line

33. It is recommended that remedial measures such as ventilation, flushing, or raising siphon intakes be implemented as soon as determinations have been made concerning the applicability of each measure to the problem. Considering the emphasis placed on energy conservation and increased productivity within most energy sources, it seems unlikely that strip-mining operations will cease or diminish in the near future. Therefore, if strip-mining operations are the major contributors of sulfates to Piedmont and Clendening Lakes, the corrosion process caused by the action of sulfur bacteria will have to be interrupted at some point after the sulfates have entered the lake water.

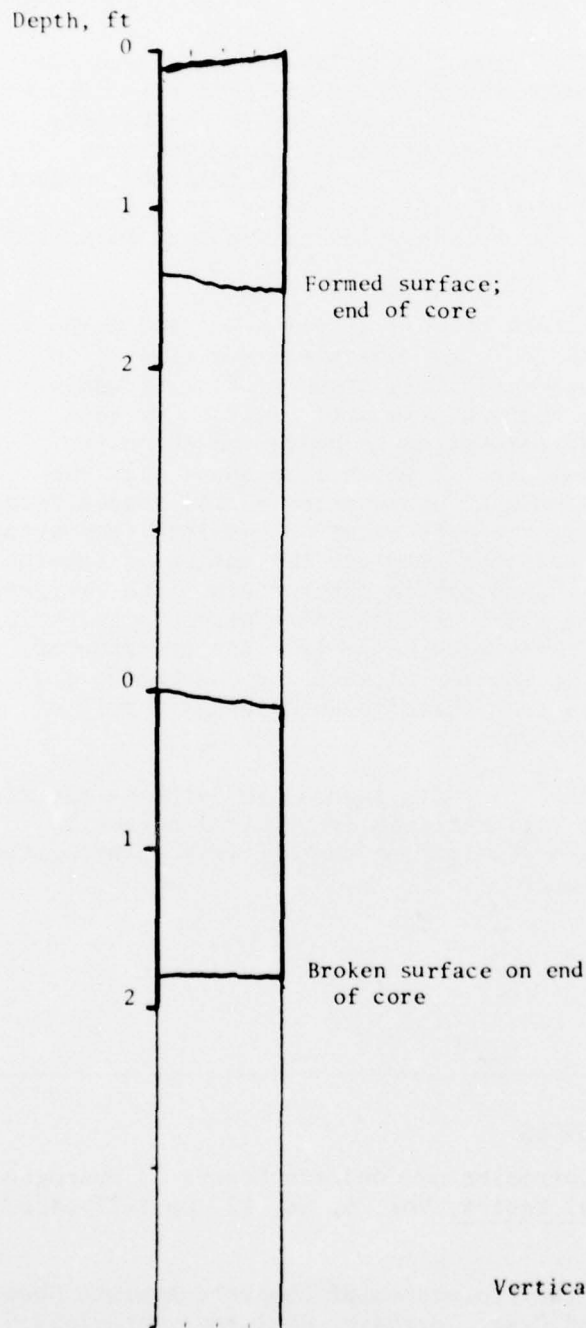
Figure A1.

Core C-1 (HUN-8 CON-1(A))
Near upstream end of tunnel.
Outer surface has aggregate
particles in relief. This
suggests removal of about
1/4 in. of original surface.

Core C-2 (HUN-8 CON-1(B))
Near midpoint of tunnel.
Aggregate in relief on
outer surface suggests
removal of about 1/8 in.
of original surface.

General Comment
Both cores are intact concrete.
They contain a natural sand and
gravel of mixed composition.
Maximum aggregate size is about
1 in. The core ends show that
tunnel surfaces are iron stained.
